RAAD VOOR DE LUCHTVAART

**AIRCRAFT ACCIDENT REPORT
94-05**

**KLM CITYHOPPER FLIGHT KL433
SAAB 340B, PH-KSH
SCHIPHOL, AMSTERDAM AIRPORT
APRIL 4, 1994**

FINAL REPORT

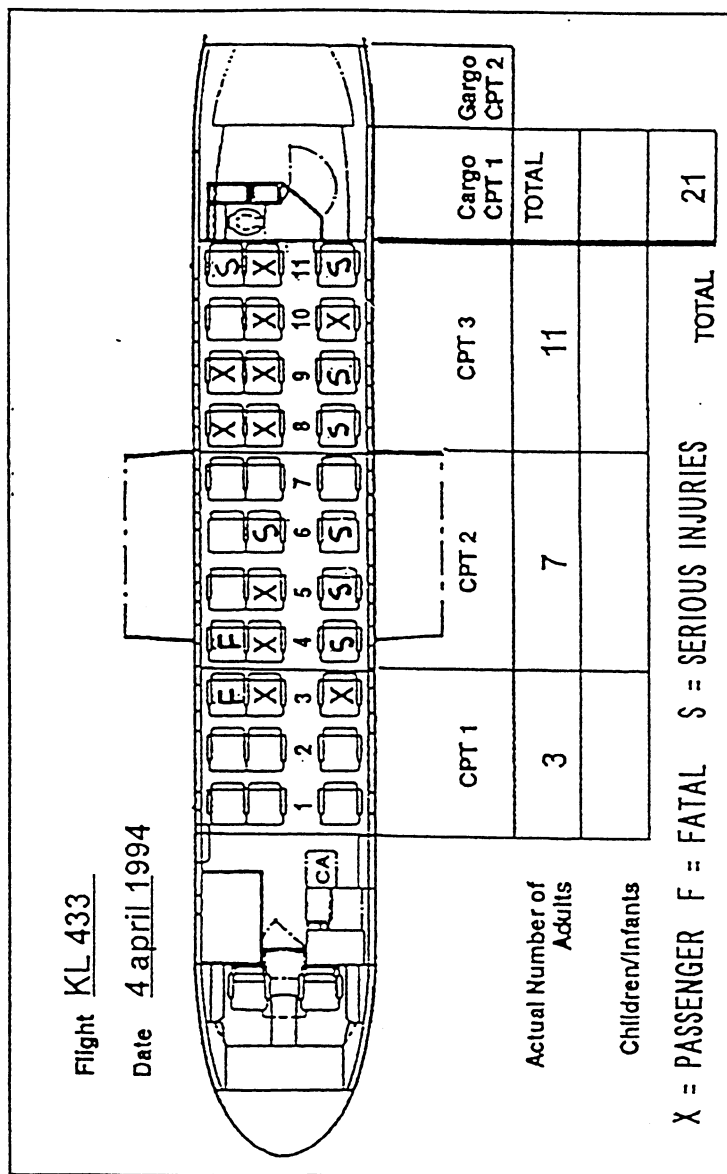
SEATING PLAN

The passengers were seated throughout the aircraft. Most of the minor or uninjured passengers were seated on the RH side of the cabin. The serious injured passengers were seated on the LH side of the cabin. Injuries varied from broken legs and arms to cuts and bruises, pelvis fractures and brain concussions. Of the wounded passengers, 8 were seriously injured and 11 suffered only minor injuries.

Saab 340B Passenger Cabin Compartments.
Seating of passengers at moment of accident.

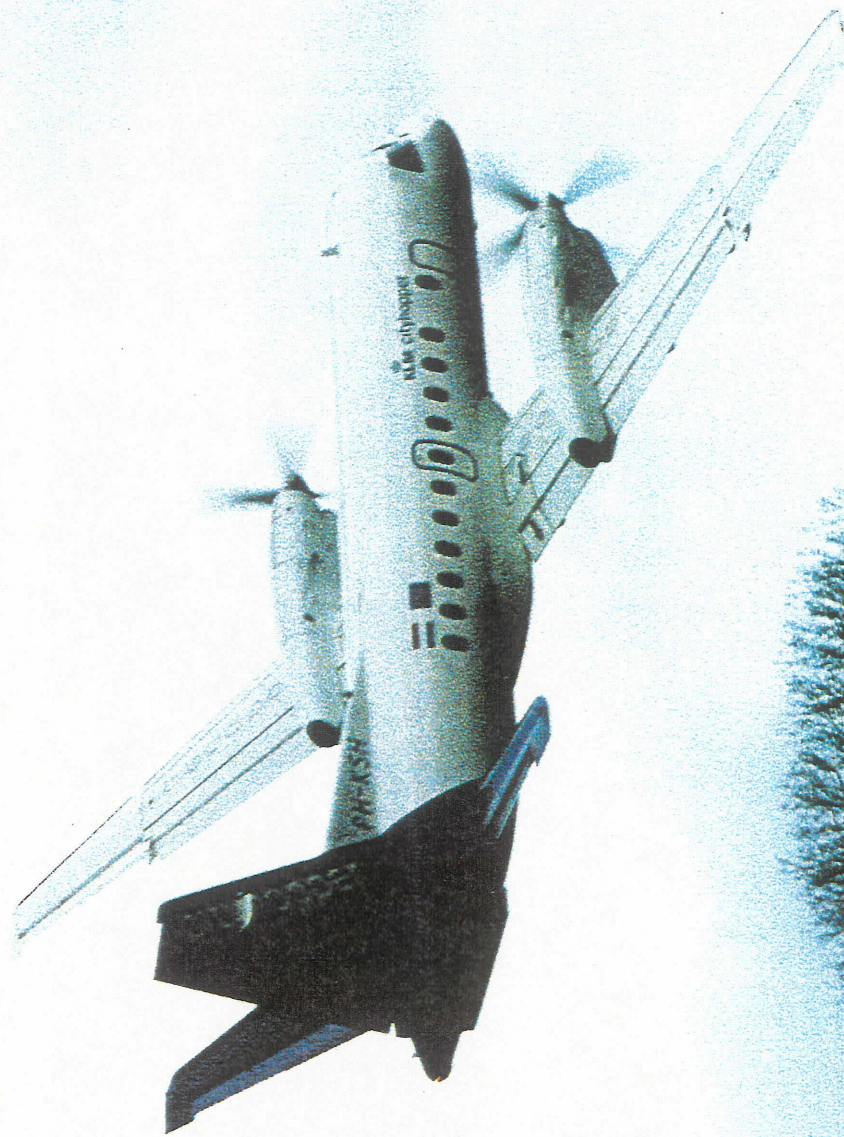
At 12:46:06, the flaps were at 7°. No conclusive data could be found on the UFDR to confirm that the landing gear reached its fully retracted position, but it could be verified from pictures taken by witnesses that the landing gear functioned normally and that it reached its fully retracted position approximately 8 seconds after the landing gear was selected up.

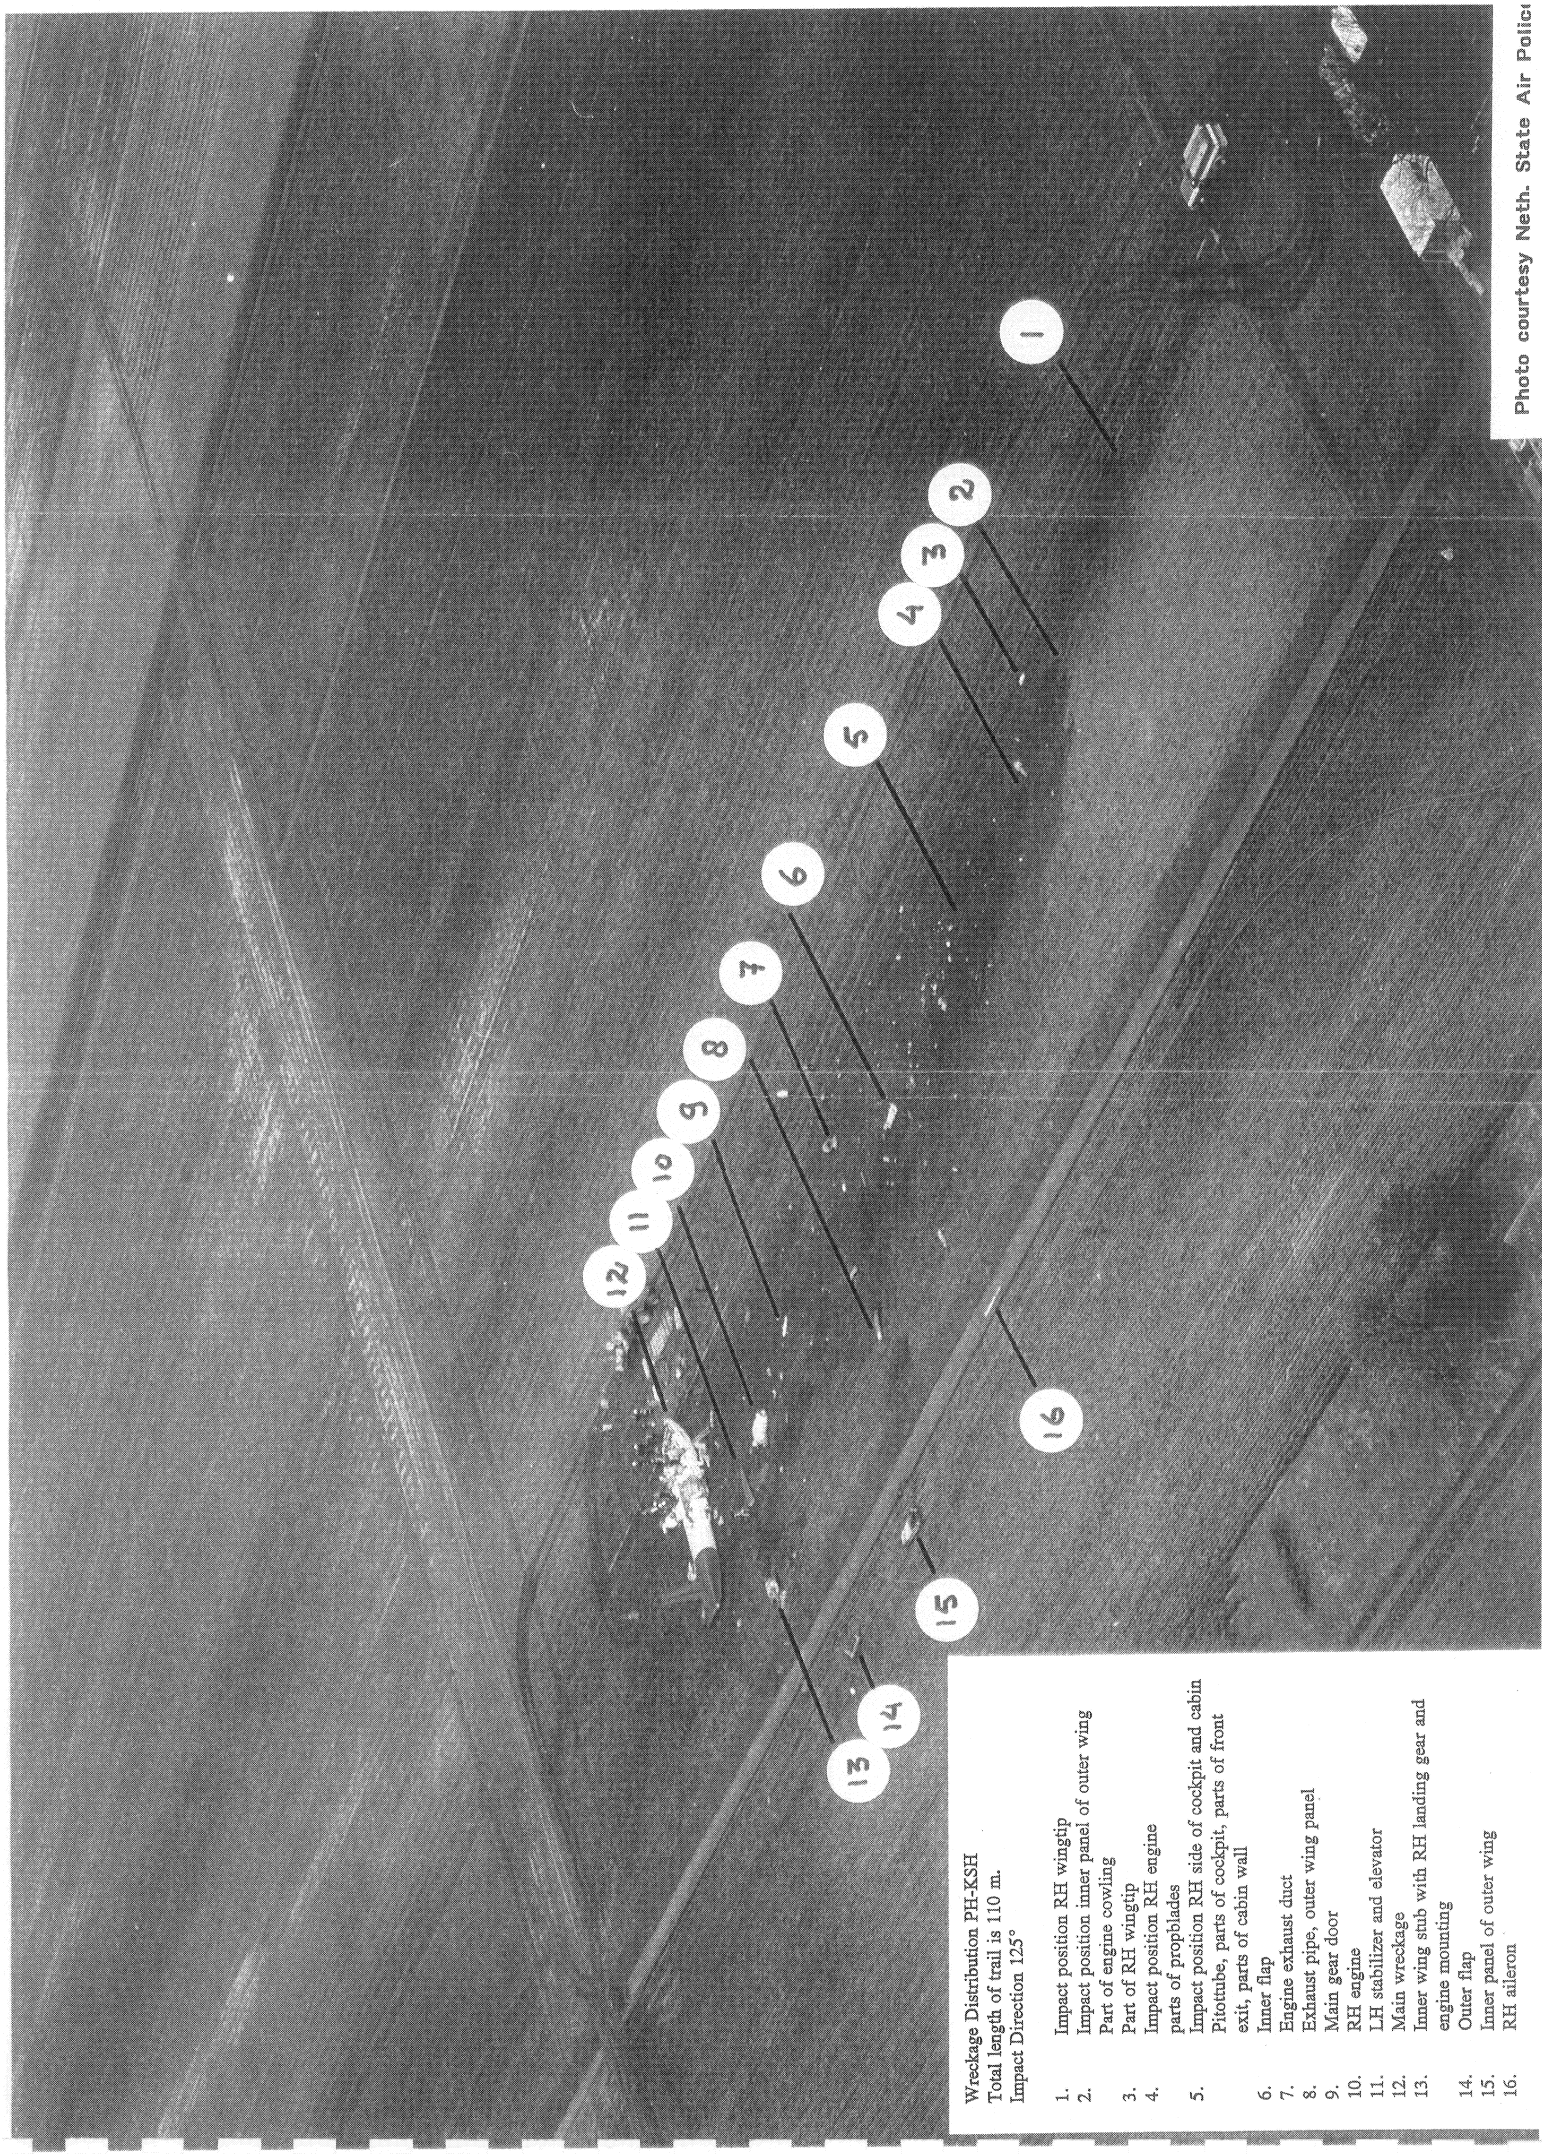
Wreckage Distribution PH-KSH
 Total length of trail is 110 m.
 Impact Direction 125°

The aircraft hit the ground in a steep right turn with a slightly nose-low attitude and approximately 80° bank to the right. The ground speed at the moment of impact was 93 knots. During the last moments of flight, the landing gear was up and the flaps were extended at 7°, as selected by the FO when the go around was initiated. The estimated damage sequence was reconstructed and is described below:

1. Impact position RH wingtip
2. Impact position inner panel of outer wing
3. Part of engine cowling
4. Part of RH wingtip
5. Impact position RH engine parts of propblades
6. Impact position RH side of cockpit and cabin Pitottube, parts of cockpit, parts of front exit, parts of cabin wall
7. Inner flap
8. Engine exhaust duct
9. Exhaust pipe, outer wing panel
10. Main gear door
11. RH engine
12. LH stabilizer and elevator
13. Main wreckage
14. Inner wing stub with RH landing gear and engine mounting
15. Outer flap
16. Inner panel of outer wing
17. RH aileron
